Hard material solves wire cutter problem

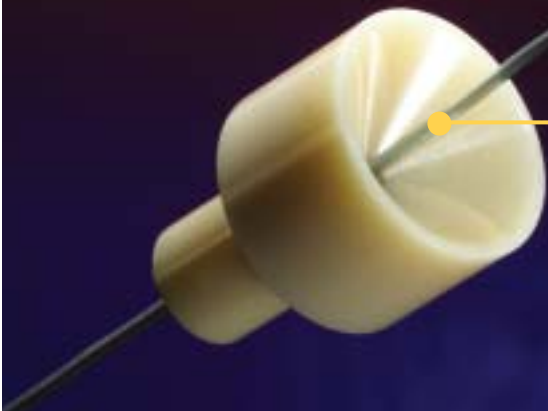
A specialized wire cutting machine used a tool-steel funnel to position a steel wire for cutting. In a short period of time, the rubbing of the wire damaged the funnel which then caused damage to the wire. This required shutting down the machine, re-arranging the inlet funnel to a smooth spot and re-starting the machine. The resulting downtime, wire loss from abrasions, and replacement of the inlet funnels became costly and difficult to manage .

Insaco engineers, working with the OEM wire cutting machine manufacturer, Crescent Design, proposed changing the funnel to a hot isostatic pressed zirconia material significantly improving wear quality when compared to metals and even most other technical ceramics.

Insaco precision fabricated the new zirconia funnels, and after two years of use there is NO noticeable wear in the inlet funnel, NO wasted material run, and virtually NO downtime. The end user is extremely pleased with the results and has ordered several more machines equipped with this new material machined by Insaco.
