## Hard material solves wire cutter problem

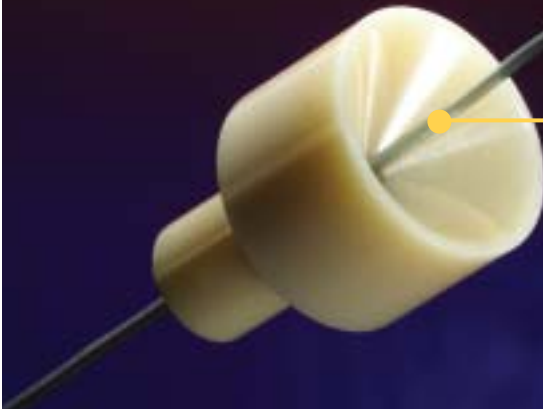
A specialized wire cutting machine used a tool-steel funnel to position a steel wire for cutting. In a short period of time, the rubbing of the wire damaged the funnel which then caused damage to the wire. This required shutting down the machine, re-arranging the inlet funnel to a smooth spot and re-starting the machine. The resulting downtime, wire loss from abrasions, and replacement of the inlet funnels became costly and difficult to manage .

Insaco engineers, working with the OEM wire cutting machine manufacturer, Crescent Design, proposed changing the funnel to a hot isostatic pressed zirconia material significantly improving wear quality when compared to metals and even most other technical ceramics.

Insaco precision fabricated the new zirconia funnels, and after two years of use there is NO noticeable wear in the inlet funnel, NO wasted material run, and virtually NO downtime. The end user is extremely pleased with the results and has ordered several more machines equipped with this new material machined by Insaco.
